INDEPENDENT ORBITER ASSESSMENT

ANALYSIS OF THE ELECTRICAL POWER GENERATION/POWER REACTANT STORAGE AND DISTRIBUTION SUBSYSTEM

WORKING PAPER NO. 1.0-WP-VA86001-11

5 December 1986

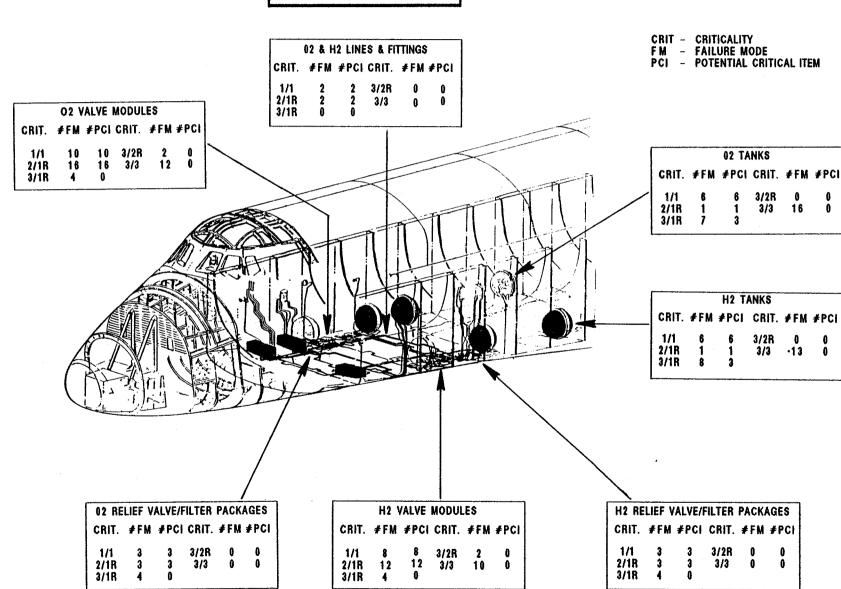
EPG/PRSD OVERVIEW ANALYSIS SUMMARY

EPG/PRSD ANALYSIS SUMMARY
CRIT. #FM #PCI CRIT. #FM #PCI
1/1 38 38 3/2R 4 0
2/1R 38 38 3/3 51 0
3/1R 31 6
